Wetland Loss Assessment by Wetland Type and Watershed in an Expanded Core Area of the Matanuska-Susitna Borough

Prepared for:
US Fish and Wildlife Service &
The Matanuska-Susitna Fish Habitat Partnership
4700 BLM Road
Anchorage, AK 99507

June 2018

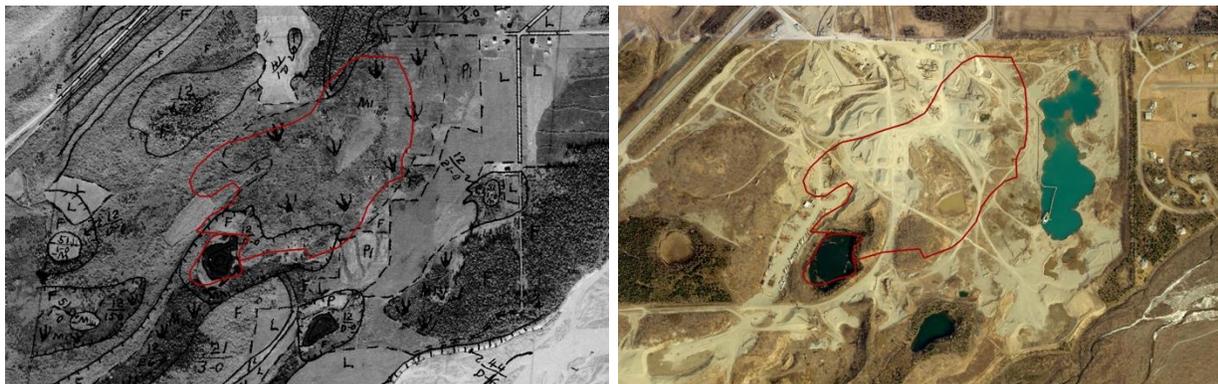
Figure 2. A wetland (red outline) in 1939 (left-hand photo) is indicated by marsh symbols drawn as part of a soils map. The same wetland has been completely filled by gravel mining activity in 2017 (right-hand photo). The Old Glenn Highway south of Palmer is visible crossing the upper left-hand corner of both photos. The braidplain of the Matanuska River covers the lower right corner of both photos.
